Cumberland Trace Townhomes 13048-13058 Thoroughbred Loop

Wind Mitigation Inspection Report

By: Fair Wind Inspections Inc.

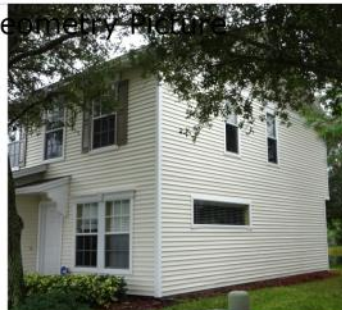
Geometry Picture

Gable end walls and/or non-hip features are greater than 10% of total perimeter

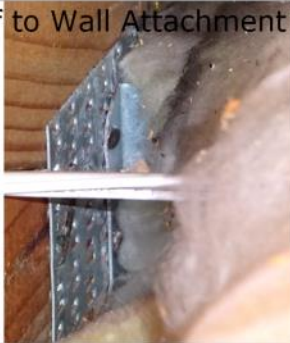
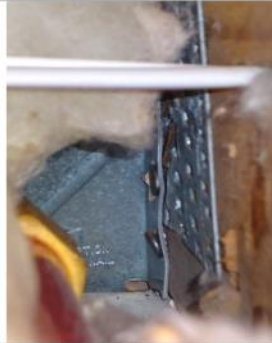
Roof to Wall Attachment:

- ☒ B. Clips
 - ☒ Metal connectors that do not wrap over the top of the truss/rafter, **or**
 - ☒ Metal connectors with a minimum of 1 strap that wraps over the top of the truss/rafter and does not meet the nail position requirements of C or D, but is secured with a minimum of 3 nails.

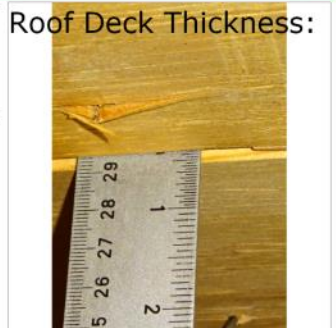
Roof Deck Thickness:

Underside of roof is in good condition
