Cumberland Trace Townhomes 13049-13059 Thoroughbred Loop

Wind Mitigation Inspection Report

By: Fair Wind Inspections Inc.

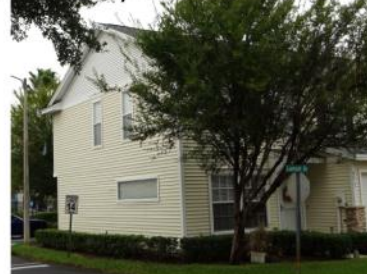
Geometry Picture

Roof Geometry: Non-Hip
 Total Non-Hip: N/A Total Perimeter: N/A
 Less Than 2:12: N/A Total Area: N/A

Gable end walls and/or non-hip features are greater than 10% of total perimeter

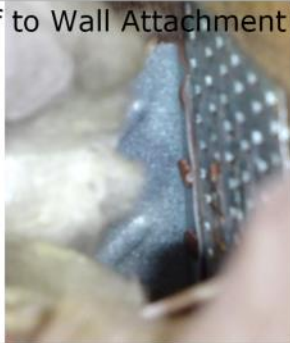
Roof to Wall Attachment:

- ☒ B. Clips
 - ☒ Metal connectors that do not wrap over the top of the truss/rafter, **or**
 - ☒ Metal connectors with a minimum of 1 strap that wraps over the top of the truss/rafter and does not meet the nail position requirements of C or D, but is secured with a minimum of 3 nails.

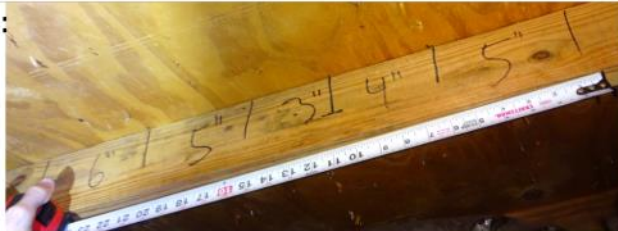
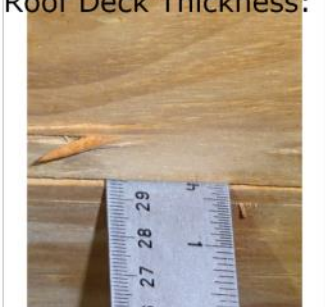
Roof Deck Thickness:

Underside of roof is in good condition

- ☒ C. Plywood/OSB roof sheathing with a minimum thickness of 7/16" inch attached to the roof truss/rafter (spaced a maximum of 24" inches o.c.) by 8d common nails spaced a maximum of 6" inches in the field. -OR- Dimensional lumber/Tongue Groove decking with a minimum of 2 nails per board (or 1 nail per board if each board is equal to or less than 6 inches in width). -OR- Any system of screws, nails, adhesives, other deck fastening system or truss/rafter spacing that is shown to have an equivalent
