# Cumberland Trace Townhomes 13120-13130 Thoroughbred Loop

## Wind Mitigation Inspection Report

By: Fair Wind Inspections Inc.

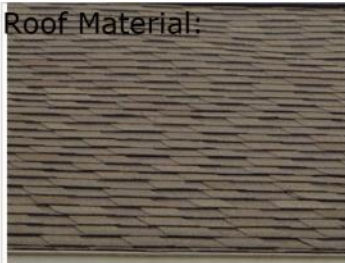
Roof Material:

Date Replaced: Oct 11, 2019  
Permit With: City of Largo  
Permit Number: BCP1910-0260  
Covering: Shingles

Roof surface is in good condition

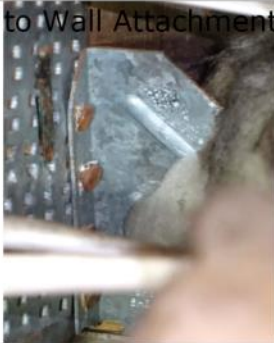
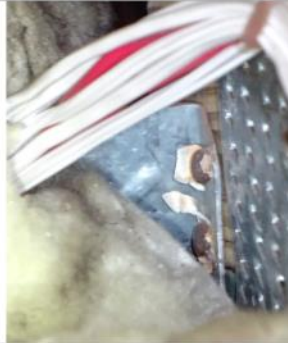
Roof to Wall Attachment:

- ☒ Secured to truss/rafter with a minimum of three (3) nails, **and**
- ☒ Attached to the wall top plate of the wall framing, or embedded in the bond beam, with less than a 1/2" gap from the blocking or truss/rafter and blocked no more than 1.5" of the truss/rafter, and free of visible severe corrosion.

- ☒ B. Clips
  - ☒ Metal connectors that do not wrap over the top of the truss/rafter, **or**
  - ☒ Metal connectors with a minimum of 1 strap that wraps over the top of the truss/rafter and does not meet the nail position requirements of C or D, but is secured with a minimum of 3 nails.

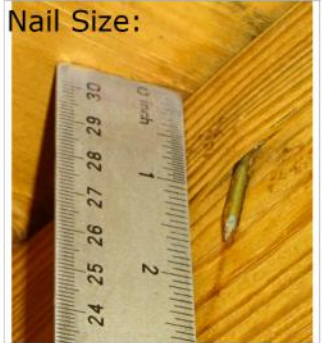
Nail Size:

Underside of roof is in good condition

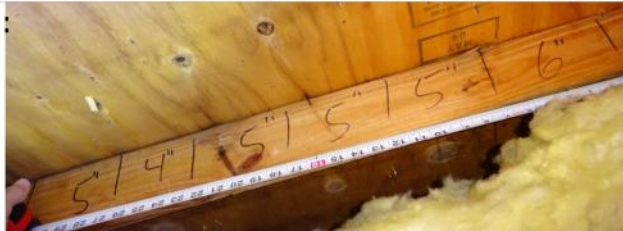
Roof Deck Thickness:

- ☒ C. Plywood/OSB roof sheathing with a minimum thickness of 7/16" inch attached to the roof truss/rafter (spaced a maximum of 24" inches o.c.) by 8d common nails spaced a maximum of 6" inches in the field. -OR- Dimensional lumber/Tongue Groove decking with a minimum of 2 nails per board (or 1 nail per board if each board is equal to or less than 6 inches in width). -OR- Any system of screws, nails, adhesives, other deck fastening system or truss/rafter spacing that is shown to have an equivalent
