Cumberland Trace Townhomes 13149-13159 Thoroughbred Loop

Wind Mitigation Inspection Report

By: Fair Wind Inspections Inc.

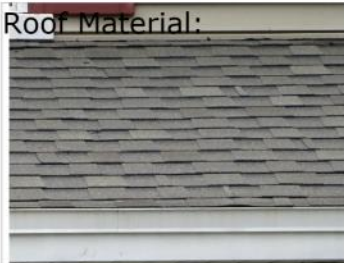
Roof Material:

Date Replaced: Oct 11, 2019
 Permit With: City of Largo
 Permit Number: BCP1910-0260
 Covering: Shingles

Roof surface is in good condition

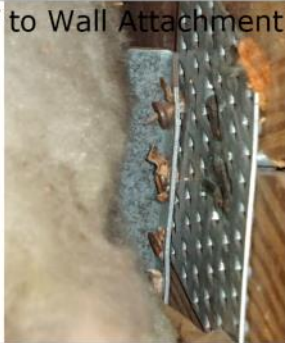
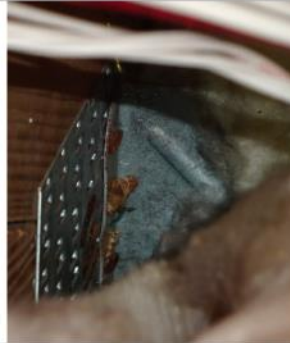
Roof to Wall Attachment:

- ☒ Secured to truss/rafter with a minimum of three (3) nails, **and**
- ☒ Attached to the wall top plate of the wall framing, or embedded in the bond beam, with less than a 1/2" gap from the blocking or truss/rafter and blocked no more than 1.5" of the truss/rafter, and free of visible severe corrosion.

- ☒ B. Clips
 - ☒ Metal connectors that do not wrap over the top of the truss/rafter, **or**
 - ☒ Metal connectors with a minimum of 1 strap that wraps over the top of the truss/rafter and does not meet the nail position requirements of C or D, but is secured with a minimum of 3 nails.

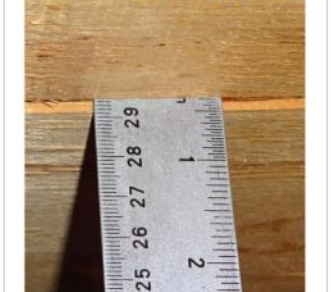
Roof Deck Thickness:

Underside of roof is in good condition

- ☒ C. Plywood/OSB roof sheathing with a minimum thickness of 7/16" inch attached to the roof truss/rafter (spaced a maximum of 24" inches o.c.) by 8d common nails spaced a maximum of 6" inches in the field. -OR- Dimensional lumber/Tongue Groove decking with a minimum of 2 nails per board (or 1 nail per board if each board is equal to or less than 6 inches in width). -OR- Any system of screws, nails, adhesives, other deck fastening system or truss/rafter spacing that is shown to have an equivalent
