Cumberland Trace Townhomes 13150-13160 Thoroughbred Loop

Wind Mitigation Inspection Report

By: Fair Wind Inspections Inc.

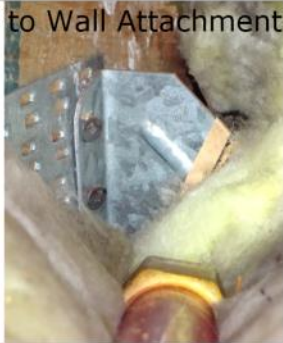
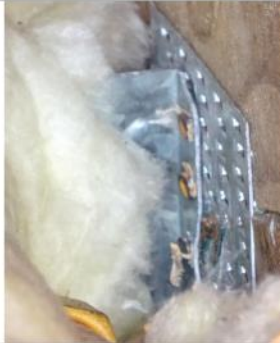
Roof to Wall Attachment:

- ☒ Secured to truss/rafter with a minimum of three (3) nails, **and**
- ☒ Attached to the wall top plate of the wall framing, or embedded in the bond beam, with less than a 1/2" gap from the blocking or truss/rafter and blocked no more than 1.5" of the truss/rafter, and free of visible severe corrosion.

- ☒ B. Clips
 - ☒ Metal connectors that do not wrap over the top of the truss/rafter, **or**
 - ☒ Metal connectors with a minimum of 1 strap that wraps over the top of the truss/rafter and does not meet the nail position requirements of C or D, but is secured with a minimum of 3 nails.

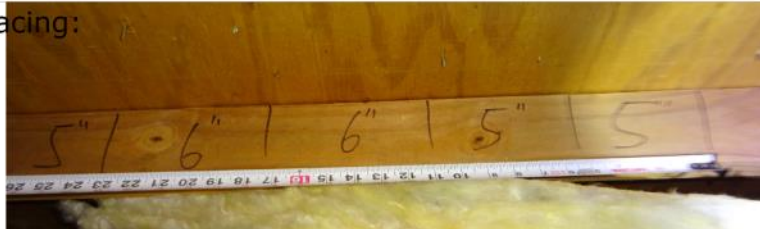
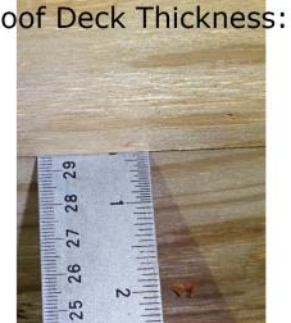
Roof Deck Thickness:

Underside of roof is in good condition

- ☒ C. Plywood/OSB roof sheathing with a minimum thickness of 7/16" inch attached to the roof truss/rafter (spaced a maximum of 24" inches o.c.) by 8d common nails spaced a maximum of 6" inches in the field. -OR- Dimensional lumber/Tongue Groove decking with a minimum of 2 nails per board (or 1 nail per board if each board is equal to or less than 6 inches in width). -OR- Any system of screws, nails, adhesives, other deck fastening system or truss/rafter spacing that is shown to have an equivalent
