Cumberland Trace Townhomes 13220-13230 Thoroughbred Loop

Wind Mitigation Inspection Report

By: Fair Wind Inspections Inc.

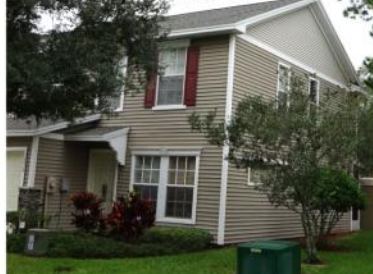
Geometry Picture

Roof Geometry: Non-Hip
Total Non-Hip: N/A Total Perimeter: N/A
Less Than 2:12: N/A Total Area: N/A

Gable end walls and/or non-hip features are greater than 10% of total perimeter

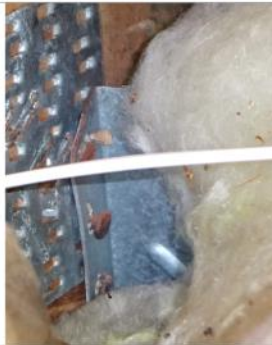
Roof to Wall Attachment:

- ☒ Secured to truss/rafter with a minimum of three (3) nails, **and**
- ☒ Attached to the wall top plate of the wall framing, or embedded in the bond beam, with less than a 1/2" gap from the blocking or truss/rafter and blocked no more than 1.5" of the truss/rafter, and free of visible severe corrosion.
- ☒ B. Clips
 - ☒ Metal connectors that do not wrap over the top of the truss/rafter, **or**
 - ☒ Metal connectors with a minimum of 1 strap that wraps over the top of the truss/rafter and does not meet the nail position requirements of C or D, but is secured with a minimum of 3 nails.
- ☐ C. Single Wraps

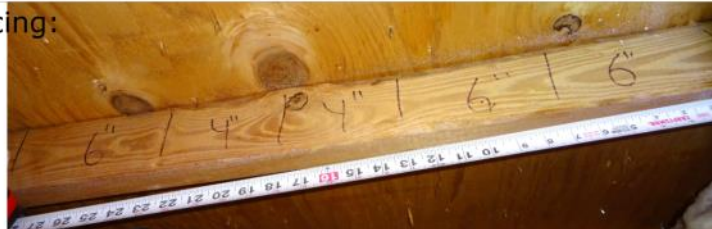
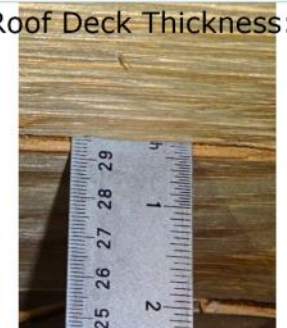
Roof Deck Thickness:

Underside of roof is in good condition

- ☒ C. Plywood/OSB roof sheathing with a minimum thickness of 7/16" inch attached to the roof truss/rafter (spaced a maximum of 24" inches o.c.) by 8d common nails spaced a maximum of 6" inches in the field. -OR- Dimensional lumber/Tongue Groove decking with a minimum of 2 nails per board (or 1 nail per board if each board is equal to or less than 6 inches in width). -OR- Any system of screws, nails, adhesives, other deck fastening system or truss/rafter spacing that is shown to have an equivalent
