Cumberland Trace Townhomes 13223-13229 Thoroughbred Loop

Wind Mitigation Inspection Report

By: Fair Wind Inspections Inc.

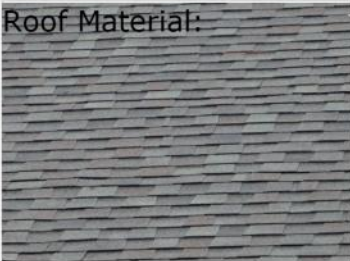
Roof Material:

Date Replaced: Oct 11, 2019
Permit With: City of Largo
Permit Number: BCP1910-0260
Covering: Shingles

Roof surface is in good condition

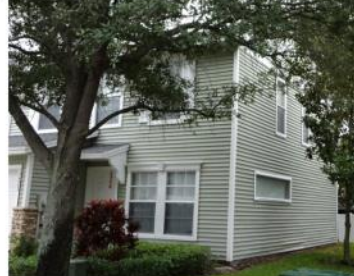
Geometry Picture

Roof Geometry: Non-Hip
Total Non-Hip: N/A
Total Perimeter: N/A
Less Than 2:12: N/A
Total Area: N/A

Gable end walls and/or non-hip features are greater than 10% of total perimeter

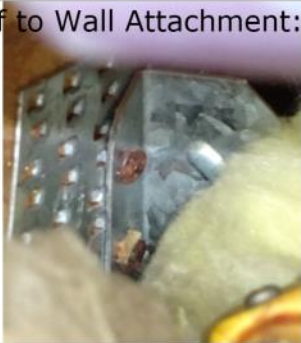
Roof to Wall Attachment:

- ☒ Secured to truss/rafter with a minimum of three (3) nails, **and**
- ☒ Attached to the wall top plate of the wall framing, or embedded in the bond beam, with less than a ½" gap from the blocking or truss/rafter and blocked no more than 1.5" of the truss/rafter, and free of visible severe corrosion.

- ☒ B. Clips
 - ☒ Metal connectors that do not wrap over the top of the truss/rafter, **or**
 - ☒ Metal connectors with a minimum of 1 strap that wraps over the top of the truss/rafter and does not meet the nail position requirements of C or D, but is secured with a minimum of 3 nails.

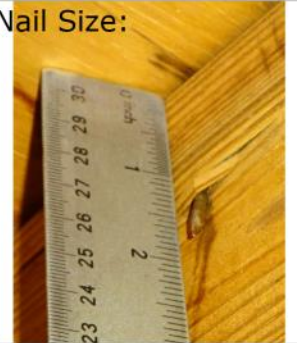
Underside of roof is in good condition

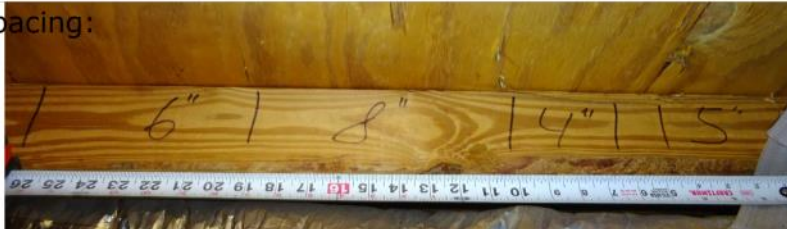
- ☒ C. Plywood/OSB roof sheathing with a minimum thickness of 7/16" inch attached to the roof truss/rafter (spaced a maximum of 24" inches o.c.) by 8d common nails spaced a maximum of 6" inches in the field. -OR- Dimensional lumber/Tongue Groove decking with a minimum of 2 nails per board (or 1 nail per board if each board is equal to or less than 6 inches in width). -OR- Any system of screws, nails, adhesives, other deck fastening system or truss/rafter spacing that is shown to have an equivalent
