Cumberland Trace Townhomes 13288-13298 Thoroughbred Loop

Wind Mitigation Inspection Report

By: Fair Wind Inspections Inc.

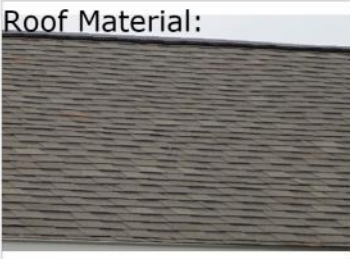
Roof Material:

Date Replaced: Oct 11, 2019
Permit With: City of Largo
Permit Number: BCP1910-0260
Covering: Shingles

Roof surface is in good condition

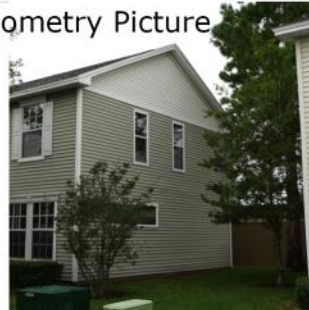
Geometry Picture

Roof Geometry: Non-Hip
Total Non-Hip: N/A Total Perimeter: N/A
Less Than 2:12: N/A Total Area: N/A

Gable end walls and/or non-hip features are greater than 10% of total perimeter

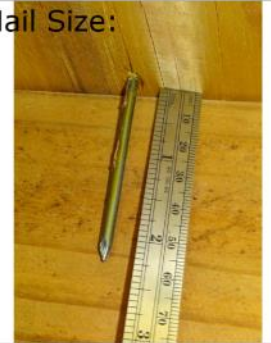
Roof to Wall Attachment:

- ☒ B. Clips
 - ☒ Metal connectors that do not wrap over the top of the truss/rafter, **or**
 - ☒ Metal connectors with a minimum of 1 strap that wraps over the top of the truss/rafter and does not meet the nail position requirements of C or D, but is secured with a minimum of 3 nails.

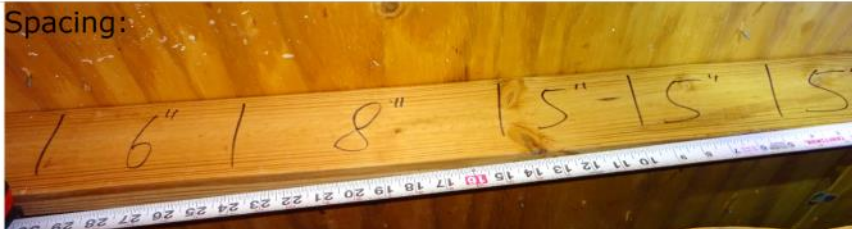
Deck Thickness:

Underside of roof is in good condition

- ☒ C. Plywood/OSB roof sheathing with a minimum thickness of 7/16" inch attached to the roof truss/rafter (spaced a maximum of 24" inches o.c.) by 8d common nails spaced a maximum of 6" inches in the field. -OR- Dimensional lumber/Tongue Groove decking with a minimum of 2 nails per board (or 1 nail per board if each board is equal to or less than 6 inches in width). -OR- Any system of screws, nails, adhesives, other deck fastening system or truss/rafter spacing that is shown to have an equivalent
