# Cumberland Trace Townhomes 13301-13321 Thoroughbred Loop

## Wind Mitigation Inspection Report

By: Fair Wind Inspections Inc.

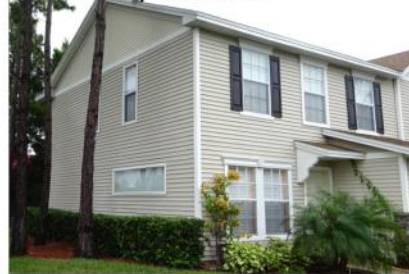
Geometry Picture

Gable end walls and/or non-hip features are greater than 10% of total perimeter

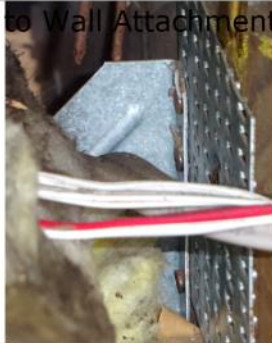
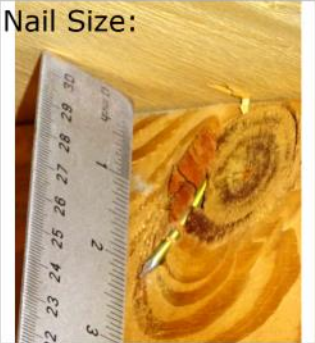
Roof to Wall Attachment:

- ☒ B. Clips
  - ☒ Metal connectors that do not wrap over the top of the truss/rafter, **or**
  - ☒ Metal connectors with a minimum of 1 strap that wraps over the top of the truss/rafter and does not meet the nail position requirements of C or D, but is secured with a minimum of 3 nails.

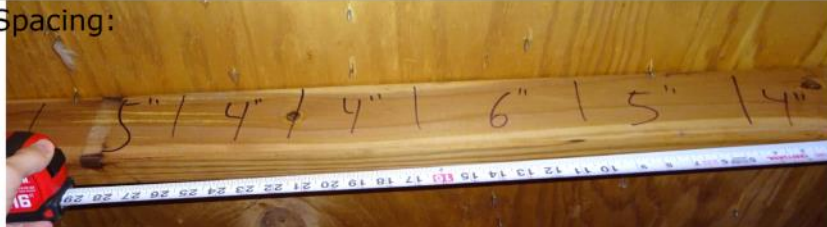
Underside of roof is in good condition

- ☒ C. Plywood/OSB roof sheathing with a minimum thickness of 7/16" inch attached to the roof truss/rafter (spaced a maximum of 24" inches o.c.) by 8d common nails spaced a maximum of 6" inches in the field. -OR- Dimensional lumber/Tongue Groove decking with a minimum of 2 nails per board (or 1 nail per board if each board is equal to or less than 6 inches in width). -OR- Any system of screws, nails, adhesives, other deck fastening system or truss/rafter spacing that is shown to have an equivalent
