# Cumberland Trace Townhomes 8000-8014 Bridal Path

## Wind Mitigation Inspection Report

By: Fair Wind Inspections Inc.

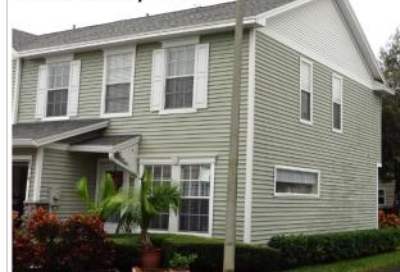
Geometry Picture

Gable end walls and/or non-hip features are greater than 10% of total perimeter

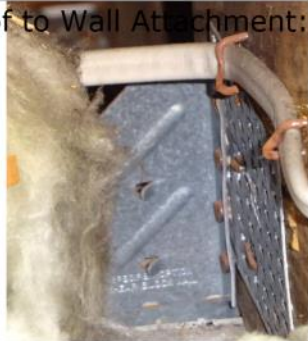
Roof to Wall Attachment:

- ☒ B. Clips
  - ☒ Metal connectors that do not wrap over the top of the truss/rafter, **or**
  - ☒ Metal connectors with a minimum of 1 strap that wraps over the top of the truss/rafter and does not meet the nail position requirements of C or D, but is secured with a minimum of 3 nails.

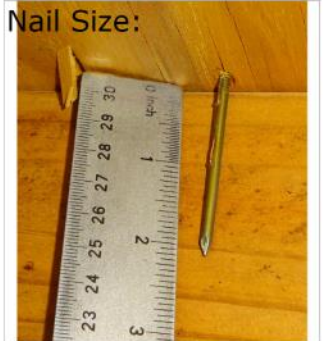
Nail Size:

Underside of roof is in good condition

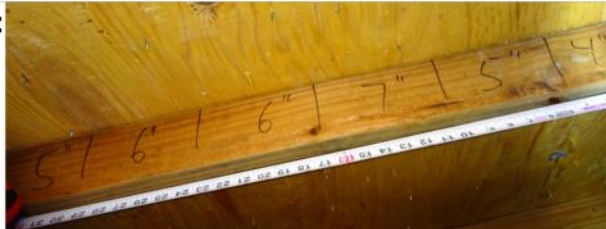
Nail Spacing:

- ☒ C. Plywood/OSB roof sheathing with a minimum thickness of 7/16" inch attached to the roof truss/rafter (spaced a maximum of 24" inches o.c.) by 8d common nails spaced a maximum of 6" inches in the field. -OR- Dimensional lumber/Tongue Groove decking with a minimum of 2 nails per board (or 1 nail per board if each board is equal to or less than 6 inches in width). -OR- Any system of screws, nails, adhesives, other deck fastening system or truss/rafter spacing that is shown to have an equivalent
