Cumberland Trace Townhomes 8000-8014 Larriott Drive

Wind Mitigation Inspection Report

By: Fair Wind Inspections Inc.

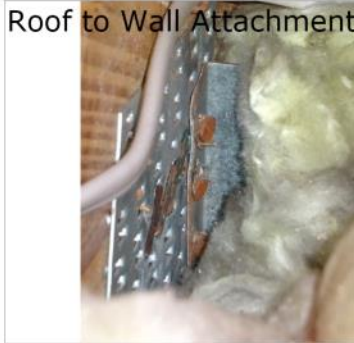
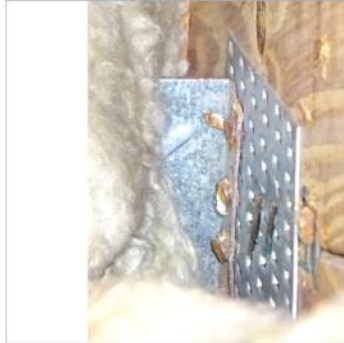
Roof to Wall Attachment:

- ☒ B. Clips
 - ☒ Metal connectors that do not wrap over the top of the truss/rafter, **or**
 - ☒ Metal connectors with a minimum of 1 strap that wraps over the top of the truss/rafter and does not meet the nail position requirements of C or D, but is secured with a minimum of 3 nails.

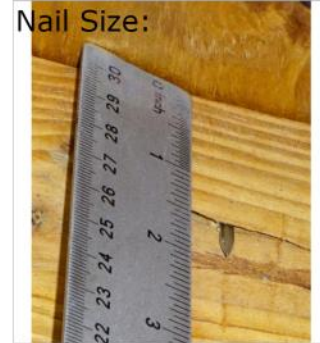
Nail Size:

Underside of roof is in good condition

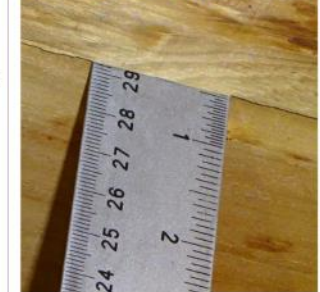
Roof Deck Thickness:

- ☒ C. Plywood/OSB roof sheathing with a minimum thickness of 7/16" inch attached to the roof truss/rafter (spaced a maximum of 24" inches o.c.) by 8d common nails spaced a maximum of 6" inches in the field. -OR- Dimensional lumber/Tongue Groove decking with a minimum of 2 nails per board (or 1 nail per board if each board is equal to or less than 6 inches in width). -OR- Any system of screws, nails, adhesives, other deck fastening system or truss/rafter spacing that is shown to have an equivalent
