# Cumberland Trace Townhomes 8001-8013 Appaloosa Dr

## Wind Mitigation Inspection Report

By: Fair Wind Inspections Inc.

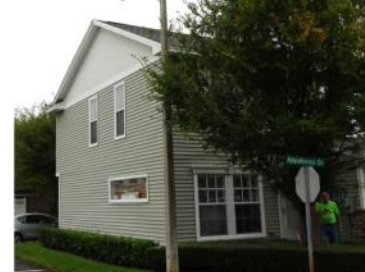
Geometry Picture

Gable end walls and/or non-hip features are greater than 10% of total perimeter

- ☐ A. Hip Roof Hip roof with no other roof shapes greater than 10% of the total roof system perimeter.  
Total length of non-hip features: N/A feet; Total roof system perimeter: N/A feet
- ☐ B. Flat Roof Roof on a building with 5 or more units where at least 90% of the main roof area has a roof slope of less than 2:12. Roof area with slope less than 2:12 N/A sq ft; Total roof area N/A sq ft
- ☒ C. Other Roof Any roof that does not qualify as either (A) or (B) above.

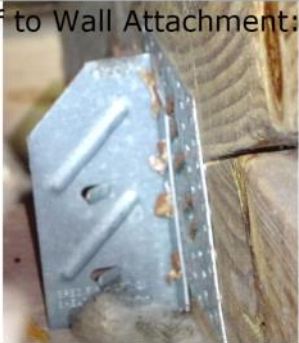
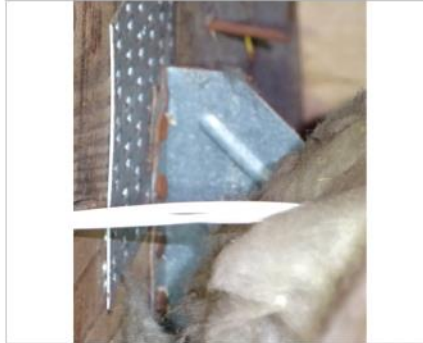
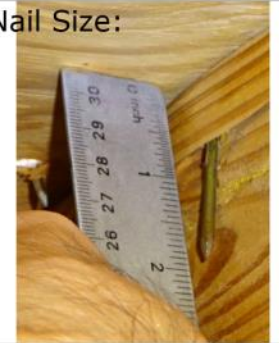
Roof to Wall Attachment:

- ☒ Secured to truss/rafter with a minimum of three (3) nails, **and**
- ☒ Attached to the wall top plate of the wall framing, or embedded in the bond beam, with less than a 1/2" gap from the blocking or truss/rafter and blocked no more than 1.5" of the truss/rafter, and free of visible severe corrosion.

- ☒ B. Clips
  - ☒ Metal connectors that do not wrap over the top of the truss/rafter, **or**
  - ☒ Metal connectors with a minimum of 1 strap that wraps over the top of the truss/rafter and does not meet the nail position requirements of C or D, but is secured with a minimum of 3 nails.

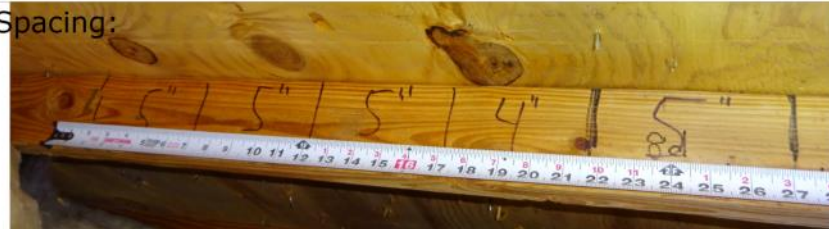
Roof Deck Thickness:

- ☒ C. Plywood/OSB roof sheathing with a minimum thickness of 7/16" inch attached to the roof truss/rafter (spaced a maximum of 24" inches o.c.) by 8d common nails spaced a maximum of 6" inches in the field. -OR- Dimensional lumber/Tongue Groove decking with a minimum of 2 nails per board (or 1 nail per board if each board is equal to or less than 6 inches in width). -OR- Any system of screws, nails, adhesives, other deck fastening system or truss/rafter spacing that is shown to have an equivalent
