# Cumberland Trace Townhomes 8001-8013 Boone Dr

## Wind Mitigation Inspection Report

By: Fair Wind Inspections Inc.

Date/Time: 11/15/2019 9 AM  
 First Name: The Townhomes at  
 Last Name: Cumberland Trace  
 Contact Number:  
 Contact Number:  
 E-mail:  
 Address: 8001-8013 Boone Dr  
 City: Largo  
 State: FL  
 Zip: 33773  
 County: Pinellas  
 Advertiser:  
 Referred By: Summer Breeze Roofing

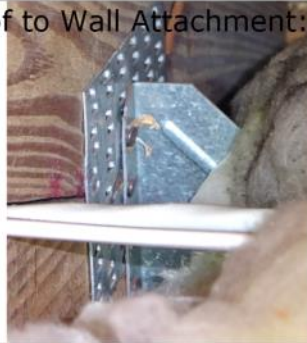
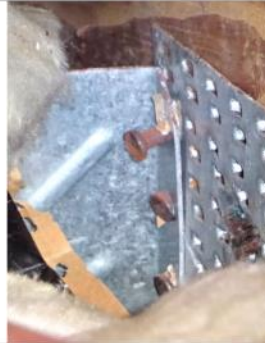
Roof to Wall Attachment:

Clip Type: Clips  
 Nails Per Clip: 3-4

Notes: Clip on each truss attaching it to the top of the wall

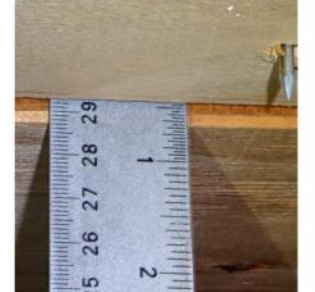
Roof Deck Thickness:

Deck Thickness: 1/2" Plywood  
 Nail Size: 8d Common  
 Nail Spacing: 6" or less

Underside of roof is in good condition
