Cumberland Trace Townhomes 8001-8013 Bridal Path

Wind Mitigation Inspection Report

By: Fair Wind Inspections Inc.

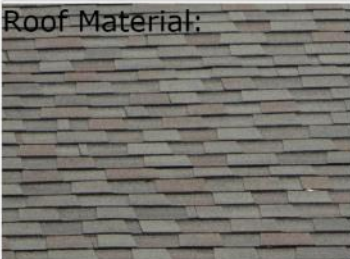
Roof Material:

Date Replaced: Oct 11, 2019
 Permit With: City of Largo
 Permit Number: BCP1910-0260
 Covering: Shingles

Roof surface is in good condition

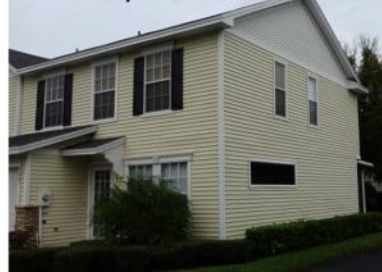
Geometry Picture

Roof Geometry: Non-Hip
 Total Non-Hip: N/A Total Perimeter: N/A
 Less Than 2:12: N/A Total Area: N/A

Gable end walls and/or non-hip features are greater than 10% of total perimeter

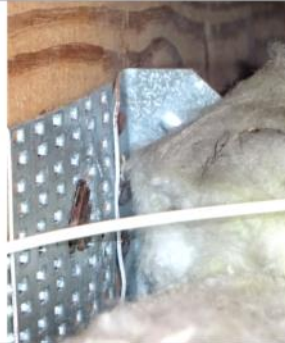
Roof to Wall Attachment:

- ☒ B. Clips
 - ☒ Metal connectors that do not wrap over the top of the truss/rafter, **or**
 - ☒ Metal connectors with a minimum of 1 strap that wraps over the top of the truss/rafter and does not meet the nail position requirements of C or D, but is secured with a minimum of 3 nails.

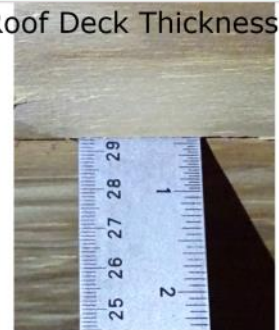
Roof Deck Thickness:

- ☒ C. Plywood/OSB roof sheathing with a minimum thickness of 7/16" inch attached to the roof truss/rafter (spaced a maximum of 24" inches o.c.) by 8d common nails spaced a maximum of 6" inches in the field. -OR- Dimensional lumber/Tongue Groove decking with a minimum of 2 nails per board (or 1 nail per board if each board is equal to or less than 6 inches in width). -OR- Any system of screws, nails, adhesives, other deck fastening system or truss/rafter spacing that is shown to have an equivalent
