Cumberland Trace Townhomes 8001-8013 Larriott Drive

Wind Mitigation Inspection Report

By: Fair Wind Inspections Inc.

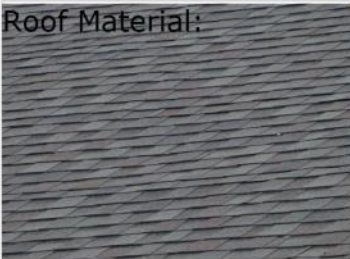
Roof Material:

Date Replaced: Oct 11, 2019
Permit With: City of Largo
Permit Number: BCP1910-0260
Covering: Shingles

Roof surface is in good condition

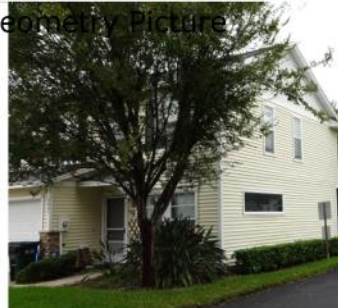
Geometry Picture

Roof Geometry: Non-Hip
Total Non-Hip: N/A Total Perimeter: N/A
Less Than 2:12: N/A Total Area: N/A

Gable end walls and/or non-hip features are greater than 10% of total perimeter

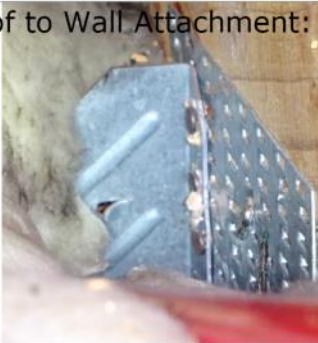
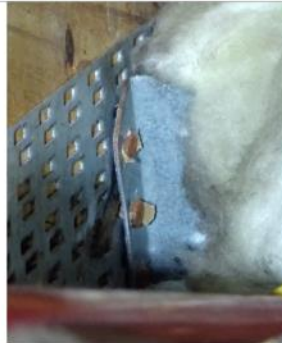
Roof to Wall Attachment:

- ☒ B. Clips
 - ☒ Metal connectors that do not wrap over the top of the truss/rafter, **or**
 - ☒ Metal connectors with a minimum of 1 strap that wraps over the top of the truss/rafter and does not meet the nail position requirements of C or D, but is secured with a minimum of 3 nails.

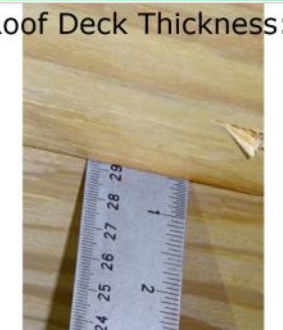
Roof Deck Thickness:

Underside of roof is in good condition

- ☒ C. Plywood/OSB roof sheathing with a minimum thickness of 7/16" inch attached to the roof truss/rafter (spaced a maximum of 24" inches o.c.) by 8d common nails spaced a maximum of 6" inches in the field. -OR- Dimensional lumber/Tongue Groove decking with a minimum of 2 nails per board (or 1 nail per board if each board is equal to or less than 6 inches in width). -OR- Any system of screws, nails, adhesives, other deck fastening system or truss/rafter spacing that is shown to have an equivalent
