# Cumberland Trace Townhomes 8001-8021 Thoroughbred Loop

## Wind Mitigation Inspection Report

By: Fair Wind Inspections Inc.

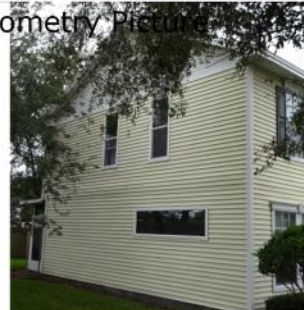
Geometry Picture

Roof Geometry: Non-Hip  
Total Non-Hip: N/A Total Perimeter: N/A  
Less Than 2:12: N/A Total Area: N/A

Gable end walls and/or non-hip features are greater than 10% of total perimeter

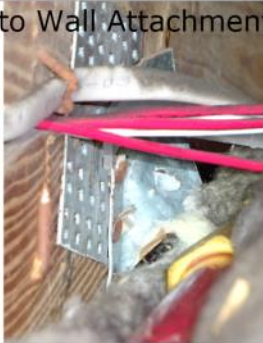
Roof to Wall Attachment:

- ☒ B. Clips
  - ☒ Metal connectors that do not wrap over the top of the truss/rafter, **or**
  - ☒ Metal connectors with a minimum of 1 strap that wraps over the top of the truss/rafter and does not meet the nail position requirements of C or D, but is secured with a minimum of 3 nails.
