# Cumberland Trace Townhomes 8030-8040 Thoroughbred Loop

## Wind Mitigation Inspection Report

By: Fair Wind Inspections Inc.

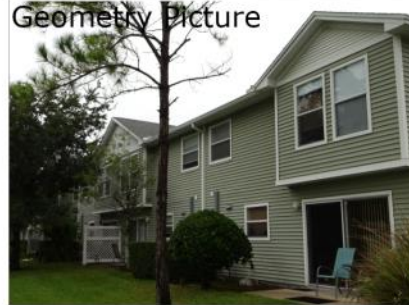
Geometry Picture

Roof Geometry: Non-Hip  
Total Non-Hip: N/A Total Perimeter: N/A  
Less Than 2:12: N/A Total Area: N/A

Gable end walls and/or non-hip features are greater than 10% of total perimeter

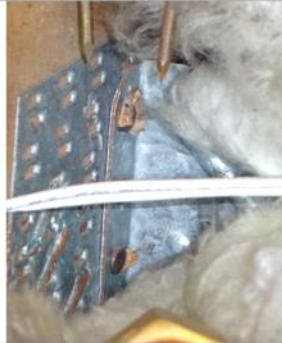
Roof to Wall Attachment:

- ☒ Secured to truss/rafter with a minimum of three (3) nails, **and**
- ☒ Attached to the wall top plate of the wall framing, or embedded in the bond beam, with less than a 1/2" gap from the blocking or truss/rafter and blocked no more than 1.5" of the truss/rafter, and free of visible severe corrosion.

- ☒ B. Clips
  - ☒ Metal connectors that do not wrap over the top of the truss/rafter, **or**
  - ☒ Metal connectors with a minimum of 1 strap that wraps over the top of the truss/rafter and does not meet the nail position requirements of C or D, but is secured with a minimum of 3 nails.

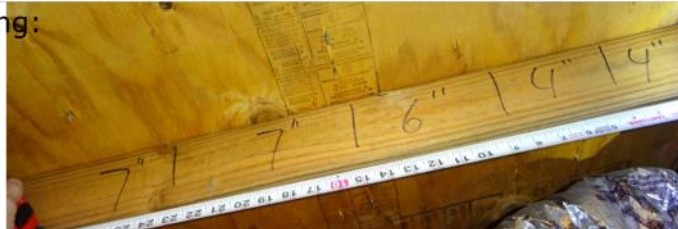
Underside of roof is in good condition

- ☒ C. Plywood/OSB roof sheathing with a minimum thickness of 7/16" inch attached to the roof truss/rafter (spaced a maximum of 24" inches o.c.) by 8d common nails spaced a maximum of 6" inches in the field. -OR- Dimensional lumber/Tongue Groove decking with a minimum of 2 nails per board (or 1 nail per board if each board is equal to or less than 6 inches in width). -OR- Any system of screws, nails, adhesives, other deck fastening system or truss/rafter spacing that is shown to have an equivalent
