# Cumberland Trace Townhomes 8031-8039 Thoroughbred Loop

## Wind Mitigation Inspection Report

By: Fair Wind Inspections Inc.

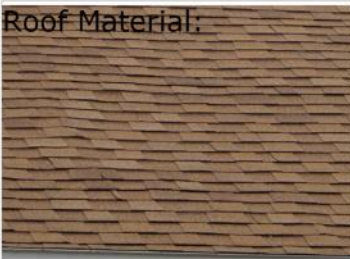
Roof Material:

Date Replaced: Oct 11, 2019  
Permit With: City of Largo  
Permit Number: BCP1910-0260  
Covering: Shingles

Roof surface is in good condition

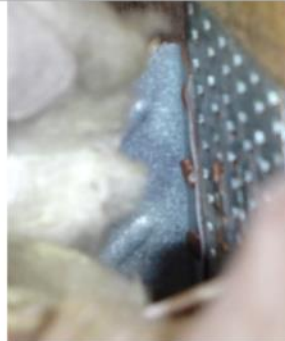
Roof to Wall Attachment:

- ☒ B. Clips
  - ☒ Metal connectors that do not wrap over the top of the truss/rafter, **or**
  - ☒ Metal connectors with a minimum of 1 strap that wraps over the top of the truss/rafter and does not meet the nail position requirements of C or D, but is secured with a minimum of 3 nails.

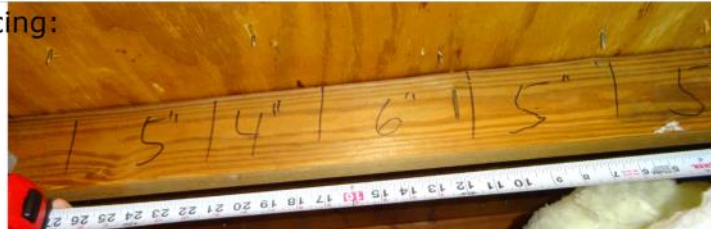
Nail Spacing:

- ☒ C. Plywood/OSB roof sheathing with a minimum thickness of 7/16" inch attached to the roof truss/rafter (spaced a maximum of 24" inches o.c.) by 8d common nails spaced a maximum of 6" inches in the field. -OR- Dimensional lumber/Tongue Groove decking with a minimum of 2 nails per board (or 1 nail per board if each board is equal to or less than 6 inches in width). -OR- Any system of screws, nails, adhesives, other deck fastening system or truss/rafter spacing that is shown to have an equivalent
