Cumberland Trace Townhomes 8050-8056 Thoroughbred Loop

Wind Mitigation Inspection Report

By: Fair Wind Inspections Inc.

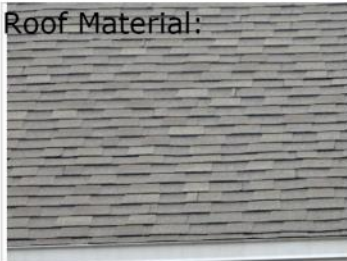
Roof Material:

Date Replaced: Oct 11, 2019
 Permit With: City of Largo
 Permit Number: BCP1910-0260
 Covering: Shingles

Roof surface is in good condition

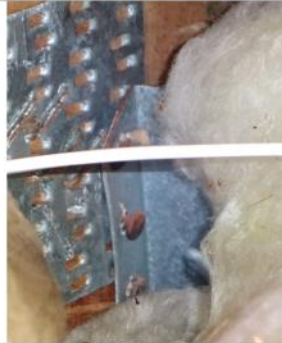
Roof to Wall Attachment:

- ☒ B. Clips
 - ☒ Metal connectors that do not wrap over the top of the truss/rafter, **or**
 - ☒ Metal connectors with a minimum of 1 strap that wraps over the top of the truss/rafter and does not meet the nail position requirements of C or D, but is secured with a minimum of 3 nails.

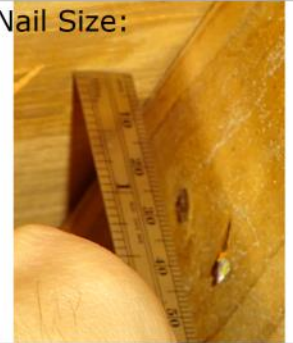
Nail Size:

Underside of roof is in good condition

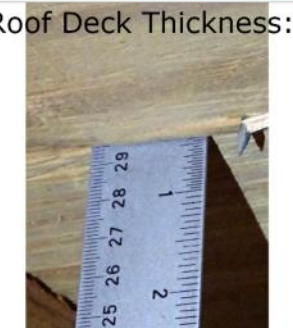
Roof Deck Thickness:

- ☒ C. Plywood/OSB roof sheathing with a minimum thickness of 7/16" inch attached to the roof truss/rafter (spaced a maximum of 24" inches o.c.) by 8d common nails spaced a maximum of 6" inches in the field. -OR- Dimensional lumber/Tongue Groove decking with a minimum of 2 nails per board (or 1 nail per board if each board is equal to or less than 6 inches in width). -OR- Any system of screws, nails, adhesives, other deck fastening system or truss/rafter spacing that is shown to have an equivalent
